V2 Fuel Tank Installation note:

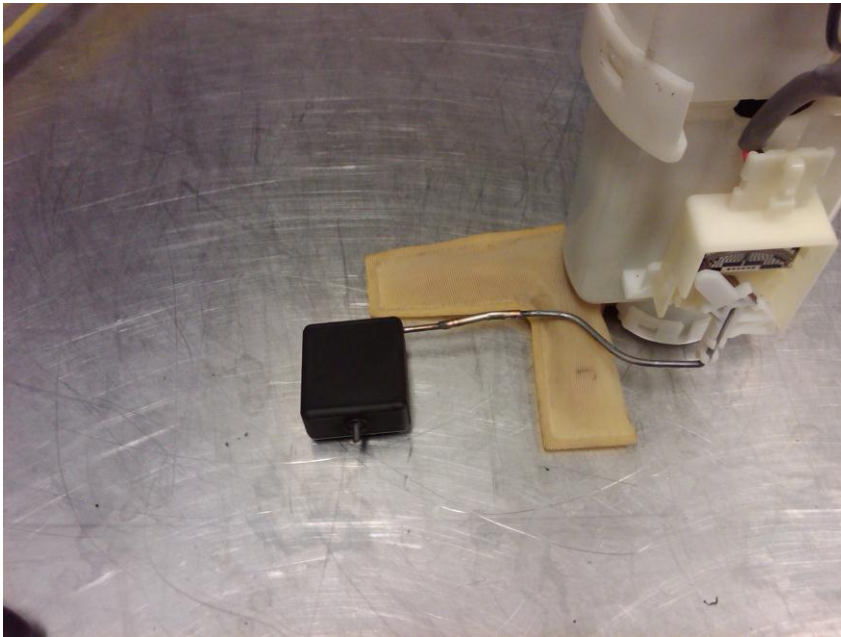
The fuel sending unit float can interfere with the newly installed tank one way doors if not modified. The OEM fuel float is positioned to the rear of the tank in top view. The new tank requires that the float rod be realigned to the center of the tank in top view. This can be easily accomplished by bending the float rod so that the float is positioned in the center of the tank in top view.

Caution! There is a coupling that is welded in the center of the float rod. DO NOT! bend the rod in this area. The OEM welding process has made the rod very brittle in this area and can easily fracture the rod is deformed in that area.
